NAVIGATIONAL RISK - OMØ SYD WIND FARM

Hazard Identification and Qualitative Risk Evaluation of the Navigational risk for the Omø Syd Wind Farm

Report No.: 1KNPOEP-3, Rev. 2

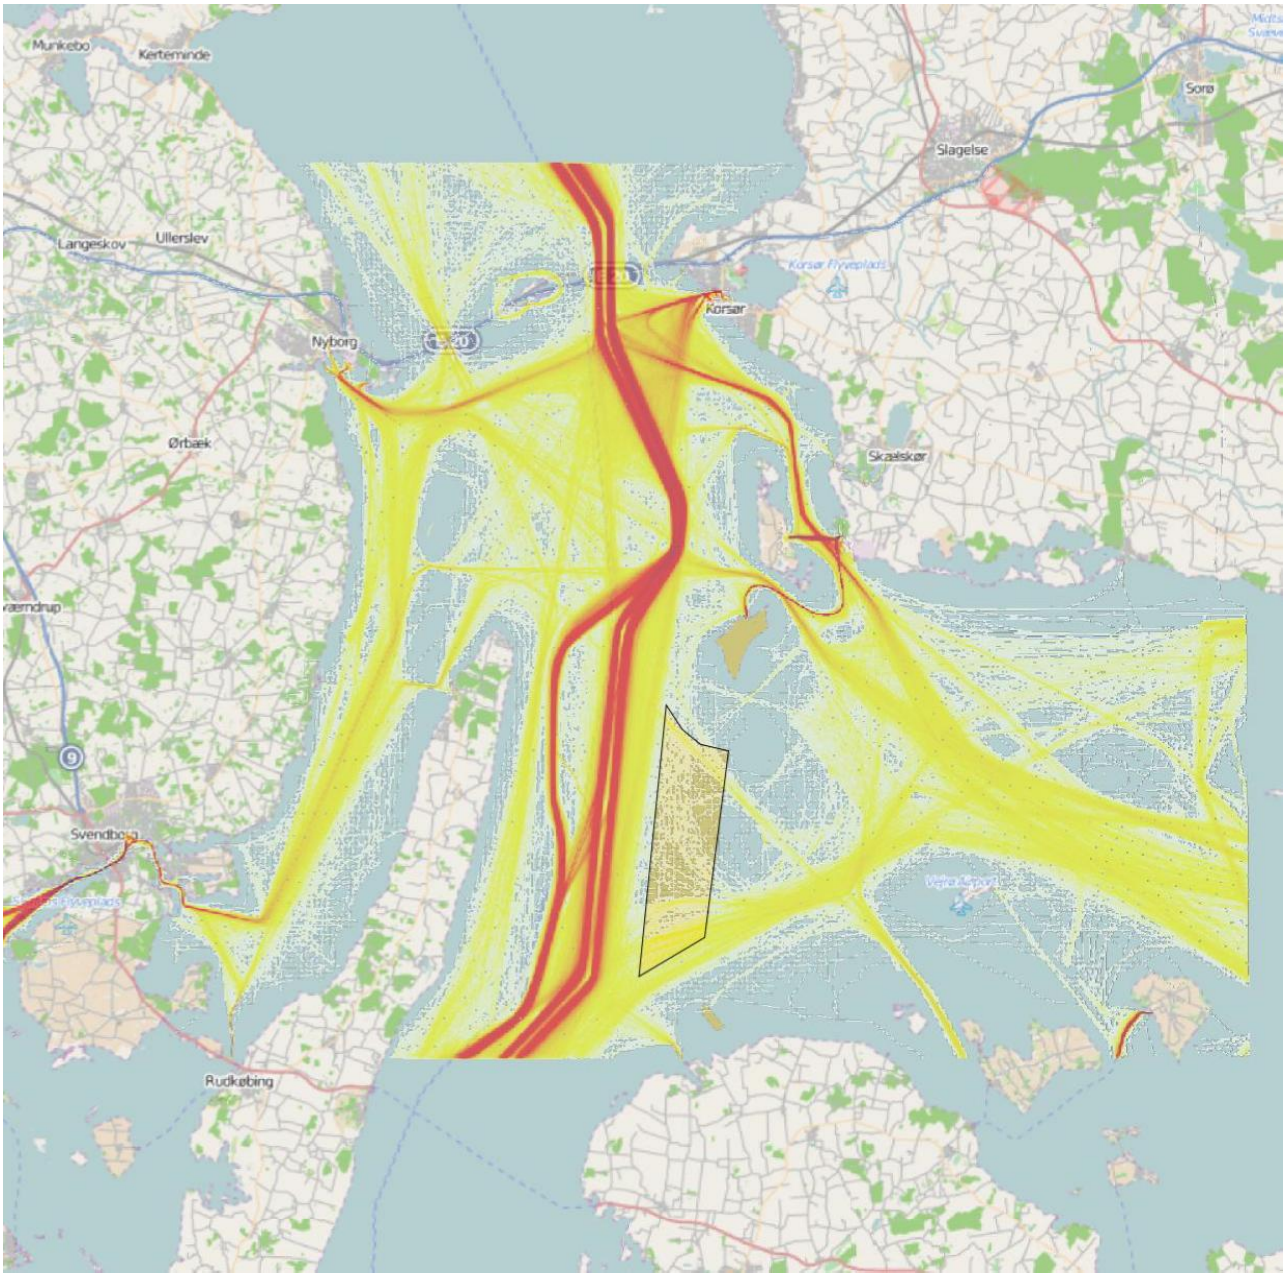
The worst case hazards are evaluated based on the mapped AIS traffic around the investigation area, which were presented at the HAZID. The mapped traffic intensities in the area are shown in Figure 2

Figure 2: Mapped traffic based on AIS

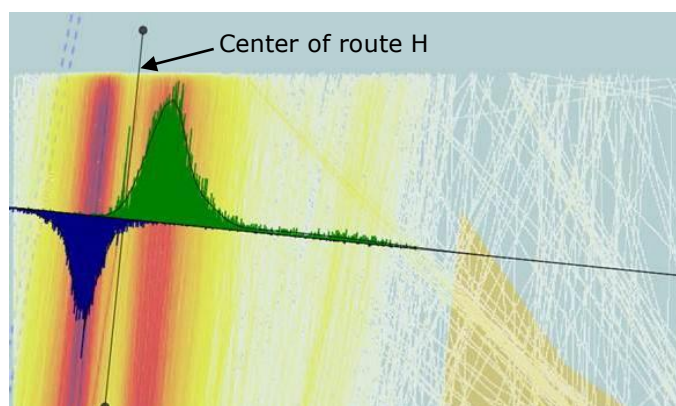
According to DMA the distance of 3-4km, mentioned in section 4, should be measured from where the actual traffic density tends to decrease. A graphic representation of such analysis is shown in Figure 4.

Figure 4: Detailed traffic density analysis of route H along with northern part of wind farm.

Figure 4 shows the AIS density with a cell size of 10m along with the lateral traffic distribution with a bin size of 5m. The associated probability distribution with mean μ and spreading β is shown in Figure 5.

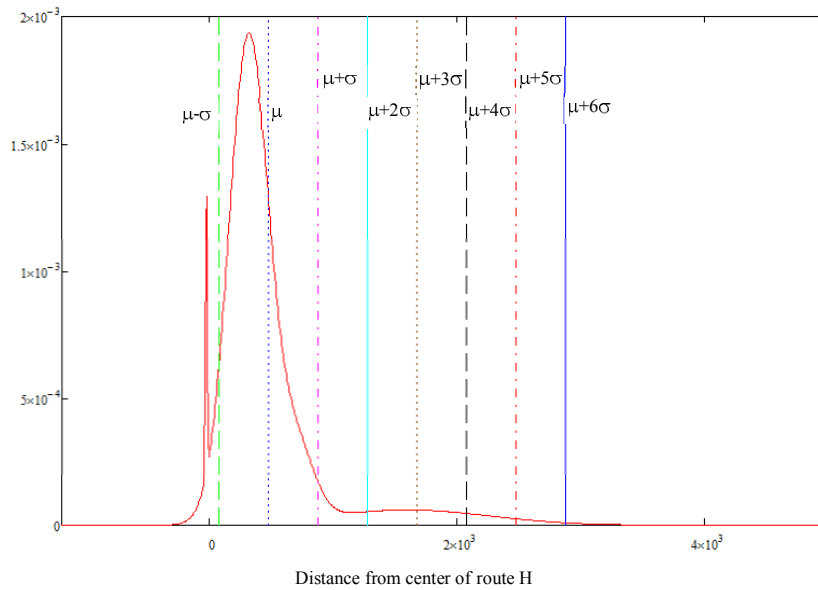
Figure 5: Probability distribution for north bound traffic on route H
